Corrosion Behavior of Sacrificial Coatings on Grade 10.9 Fasteners for Multimetal Armor Applications

ARL-TR-6538

August 2013

Army Research Laboratory

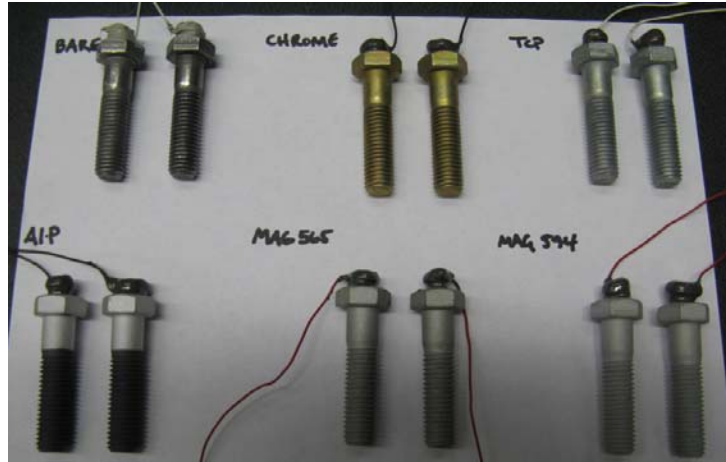
Figure 2. Prepared bolts prior to immersion in thermostatic bath.

A thermostatic bath was filled with a 5% NaCl solution. This bath was heated to 75 °F for the duration of the experiment and was constantly agitated by an internal mechanism. For each bolt candidate and baseline (figure 2), two were immersed in the solution for a period of 500 h. Open circuit potential (OCP) measurements were taken at 1, 2, 4, 8, and 24 h, then every 24 h following that using a digital multimeter.

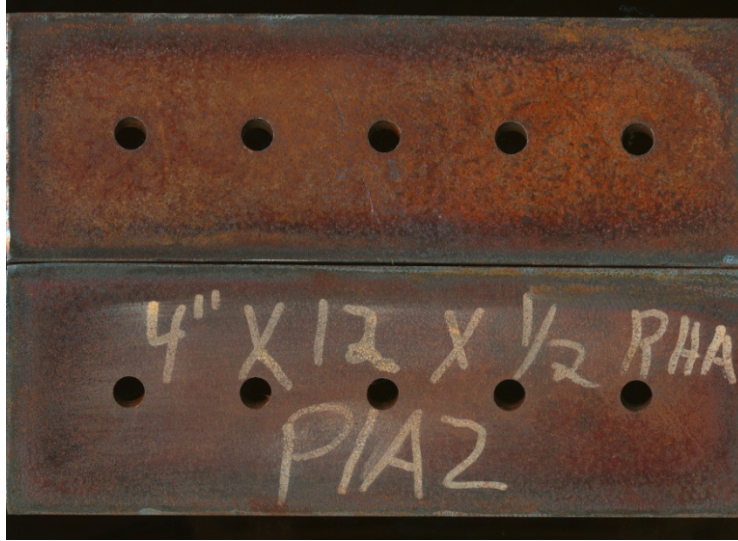
Figure 3. RHA steel prior to surface finishing.

Preparation for the GM9540P (7) cyclic corrosion tests involved creating test jigs to simulate bolt-on armor. Steel and Al plates were prepared as shown in figures 2 and 3. All of the steel and Al plates had either five 13-mm-diameter *through* holes or five 13-mm *threaded* holes. The face plate of each set was equipped with *through* holes, whereas the base plate was the one equipped with *threaded* holes. Each bolt was placed through the face plate and affixed into the base plate with the *threaded* holes. The plates were approximately 4-in wide by 12-in long and were of various thicknesses. Table 1 shows a list of the plates used in this experiment.

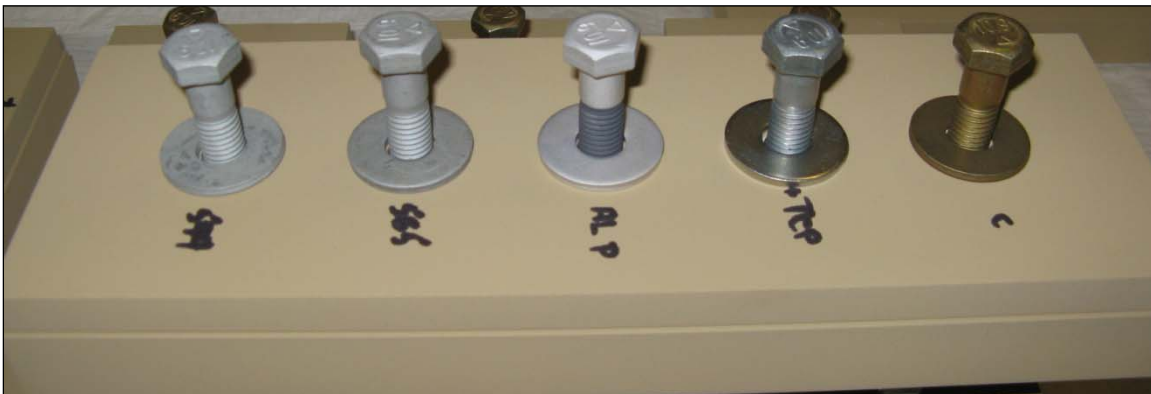
Figure 5. Photograph of plate assembly prior to final assembly (from left to right: Magniplate 594, Magniplate 565, Alumiplate, TCP, Hexavalent chrome).

consists of two replicates of this combination: one AL 5059 (1-in-thick) plate that was blasted, pretreated with TCP, and CARC coated, coupled with one RHA Steel (1/2-in-thick) plate that was blasted, pretreated with TCP, and CARC coated. All groups have one of each bolt (figure 5)

Each bolt was hand fastened into the test plates, using a box wrench when necessary, using its corresponding washer. A calibrated torque wrench was then used to apply a 60-in-lb load on each of the seated fasteners. The plate assemblies were labeled 1–18, and each of the fasteners was labeled on the surface of the plate for easy identification. Each plate assembly was placed into a GM 9540P test chamber at an angle that was dictated by the protrusion of the fastener from the back of the assembly. Care was taken to ensure that the angle for all assemblies was similar (figures 5 and 6).

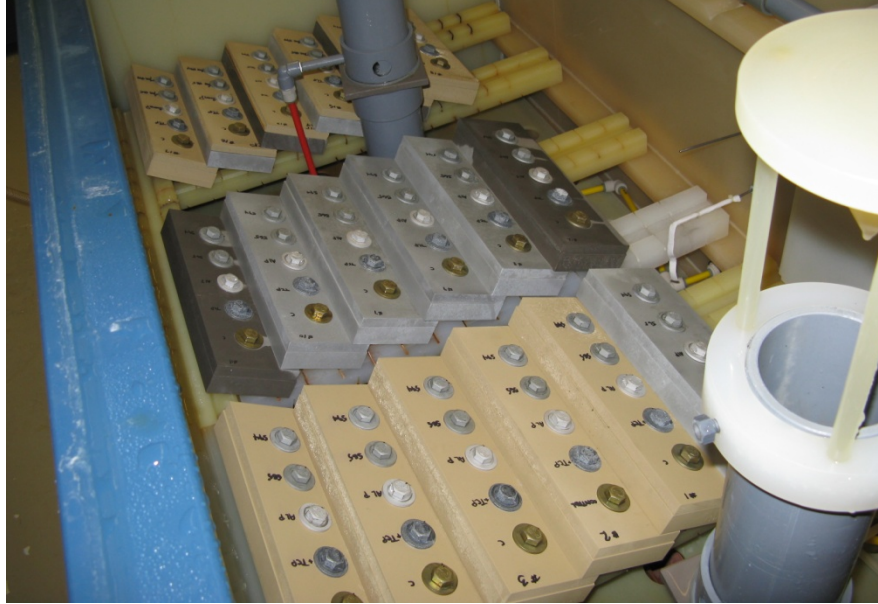
Figure 6. Bolt-in-plate arrays loaded in GM9540P accelerated corrosion chamber prior to testing.

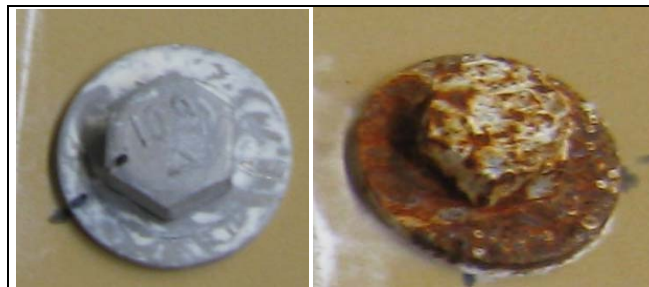
Figure 7. Examples of “frosting” and “red rust.”

Observations and evaluations were made at 20-cycle intervals to identify the percentage of the fastener head and washer that had either begun “frosting” prior to the onset of the steel/iron in the fastener, as well as the percentage of the fastener and washer that had been affected by “red rust” (examples of which can be seen in figure 7). After the full duration of 120 cycles, each fastener was removed from the assembly using a calibrated torque wrench, and the break-away torque was recorded.

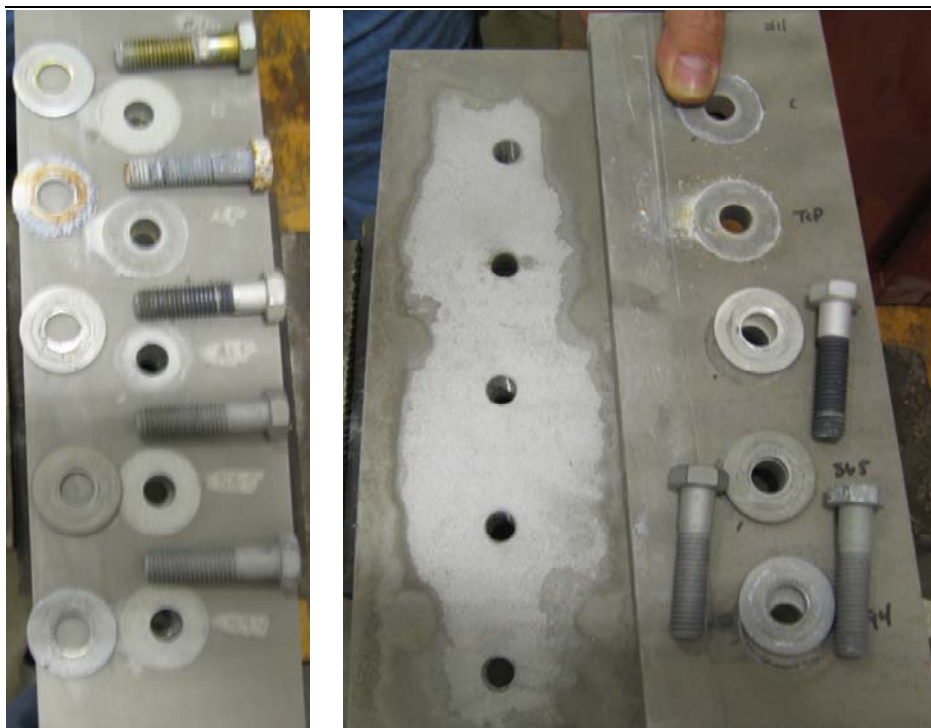
Figure A-4. Panels 10 and 11 disassembled after 120 cycles GM9540P (including interior shot to show moisture penetration on panel 11).
